# Manhole Inspection Summary

Manhole # S21A\_\_048MH

Insp Date: **9/18/07 10:50 AM**

**Location** Address: **600 FULTON AVE**

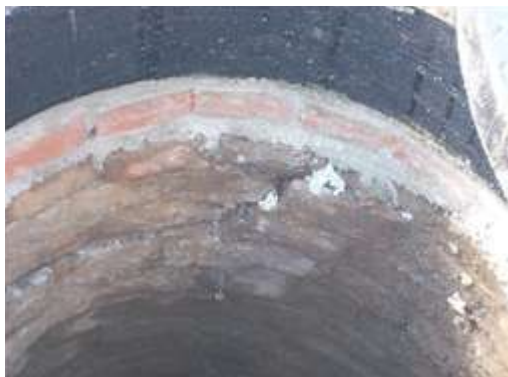
Defect 3

Condition: ☐ Sound ☒ **Cracked** ☐ Root Intrusion ☒ **Loose Brick** ☒ **Deteriorated**

HUGE CORBEL CRACK

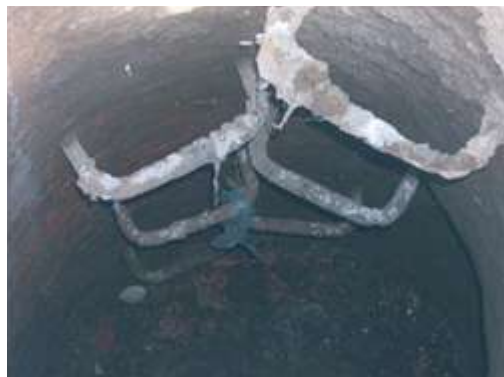
Defect 2

CORRODED STEPS and evidence  
surcharge

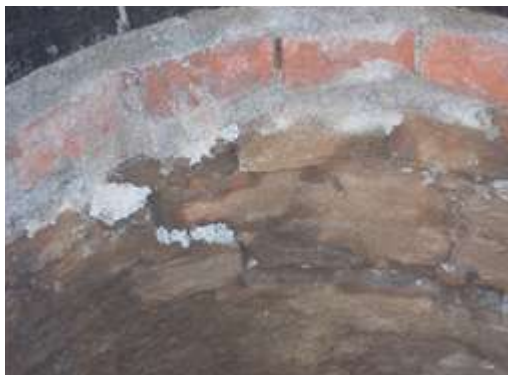
Defect 1

LOOSE CORBEL BRICKS

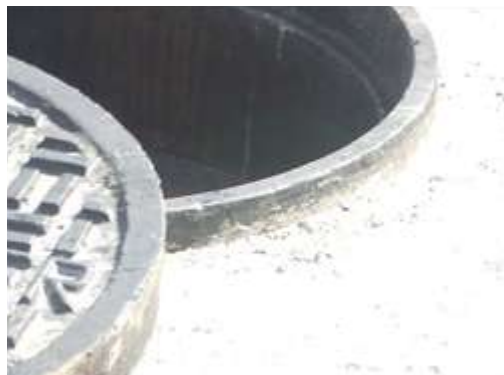
Defect 4

GRADE ADJ

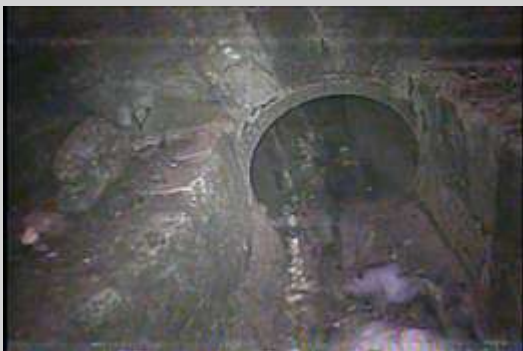
3 O'Clock Inflow

Pipe Height: **7.2** (in.) Rod and Bar (Angled)  
Pipe Material: **Clay** ☐ Pipe Lined  
Invert Depth: **11.79** (ft.) Flow Characteristics: **Slow**  
Deposits: ☐ None ☐ Mud ☒ **Sludge** ☐ Debris ☐ Grease  
Silt Depth: **1** (in.) Deposits Extent: **Light**  
Infiltration: **None** Pipe Seal Cond: **Sound**
